## Surveying at the

# State State Capitol Dome

t was a dark November evening; it was snowing, and our survey crew was more than 200-feet in the air atop the Utah State Capitol Dome, freezing. David Evans and Associates, Inc. (DEA) had been contracted to provide as-built drawings for the restoration of the historic capitol dome. This task presented several challenges ranging from how to meet the accuracy requirements and tight schedule to how to collect and convey the data in a useful format. DEA responded by using a combination of laser scanning and conventional survey methods to provide highly accurate and easily usable data on a tight timeline.

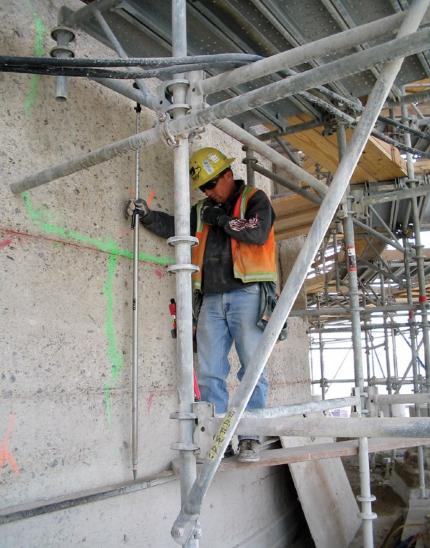
**Top:** Utah State Capitol with drum surrounded by scaffolding.

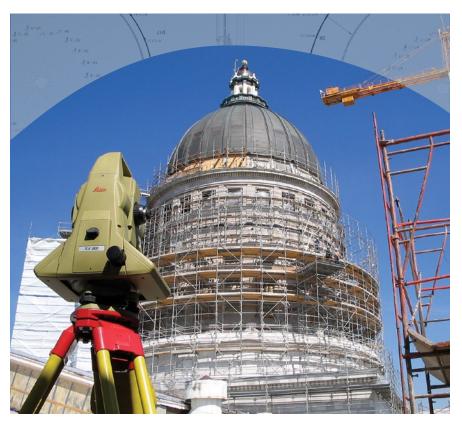
Upper and lower drums surrounded by scaffolding just prior to tile installation.
